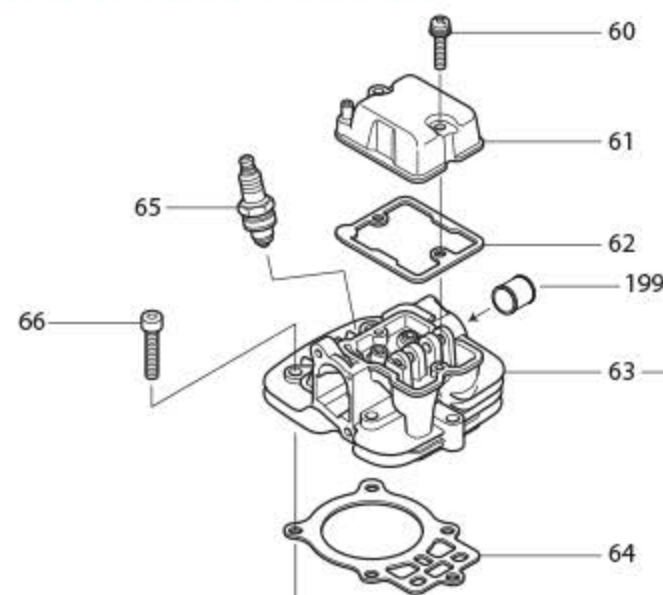
NOTICE: 199 with **TYPE 2** cylinder head only.

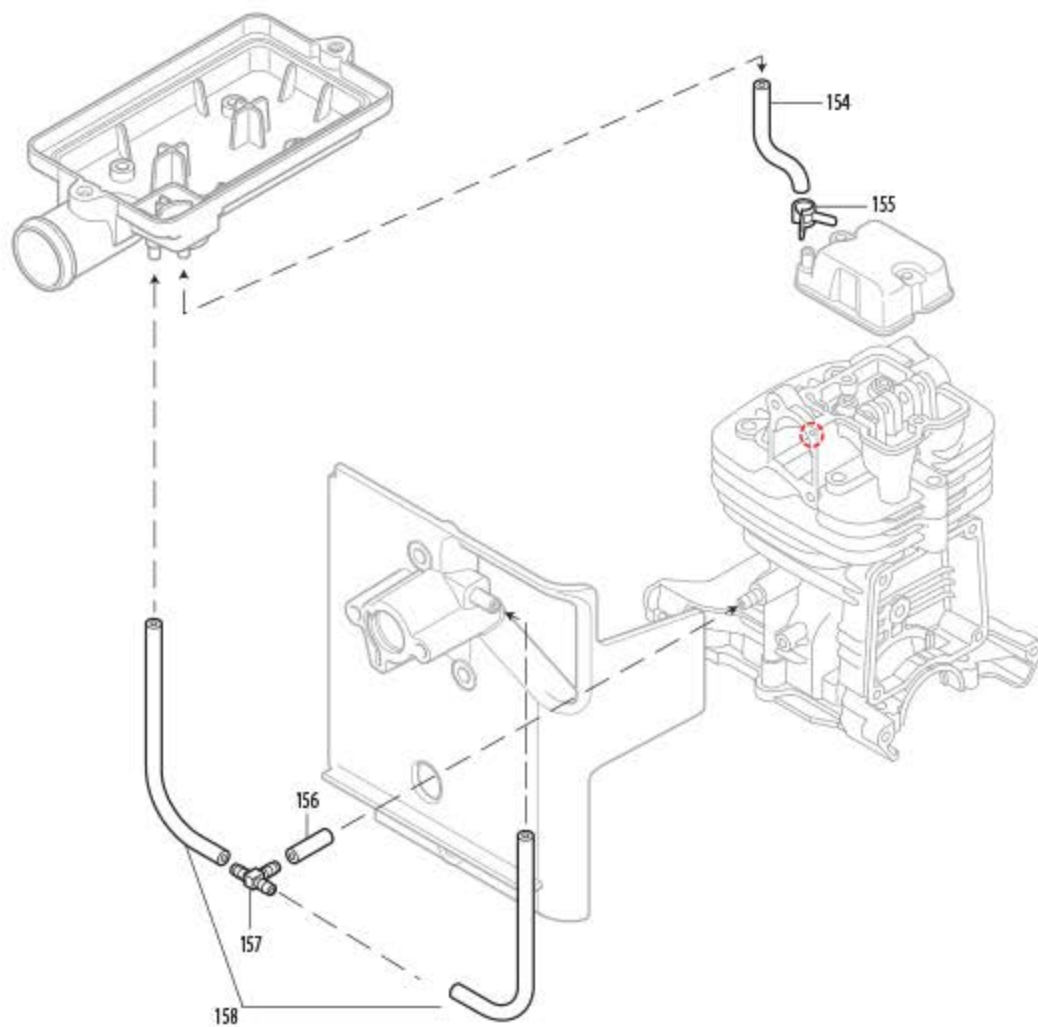
TYPE 1 - OIL TUBE ASSEMBLY

TYPE 1

Oil return passage here.

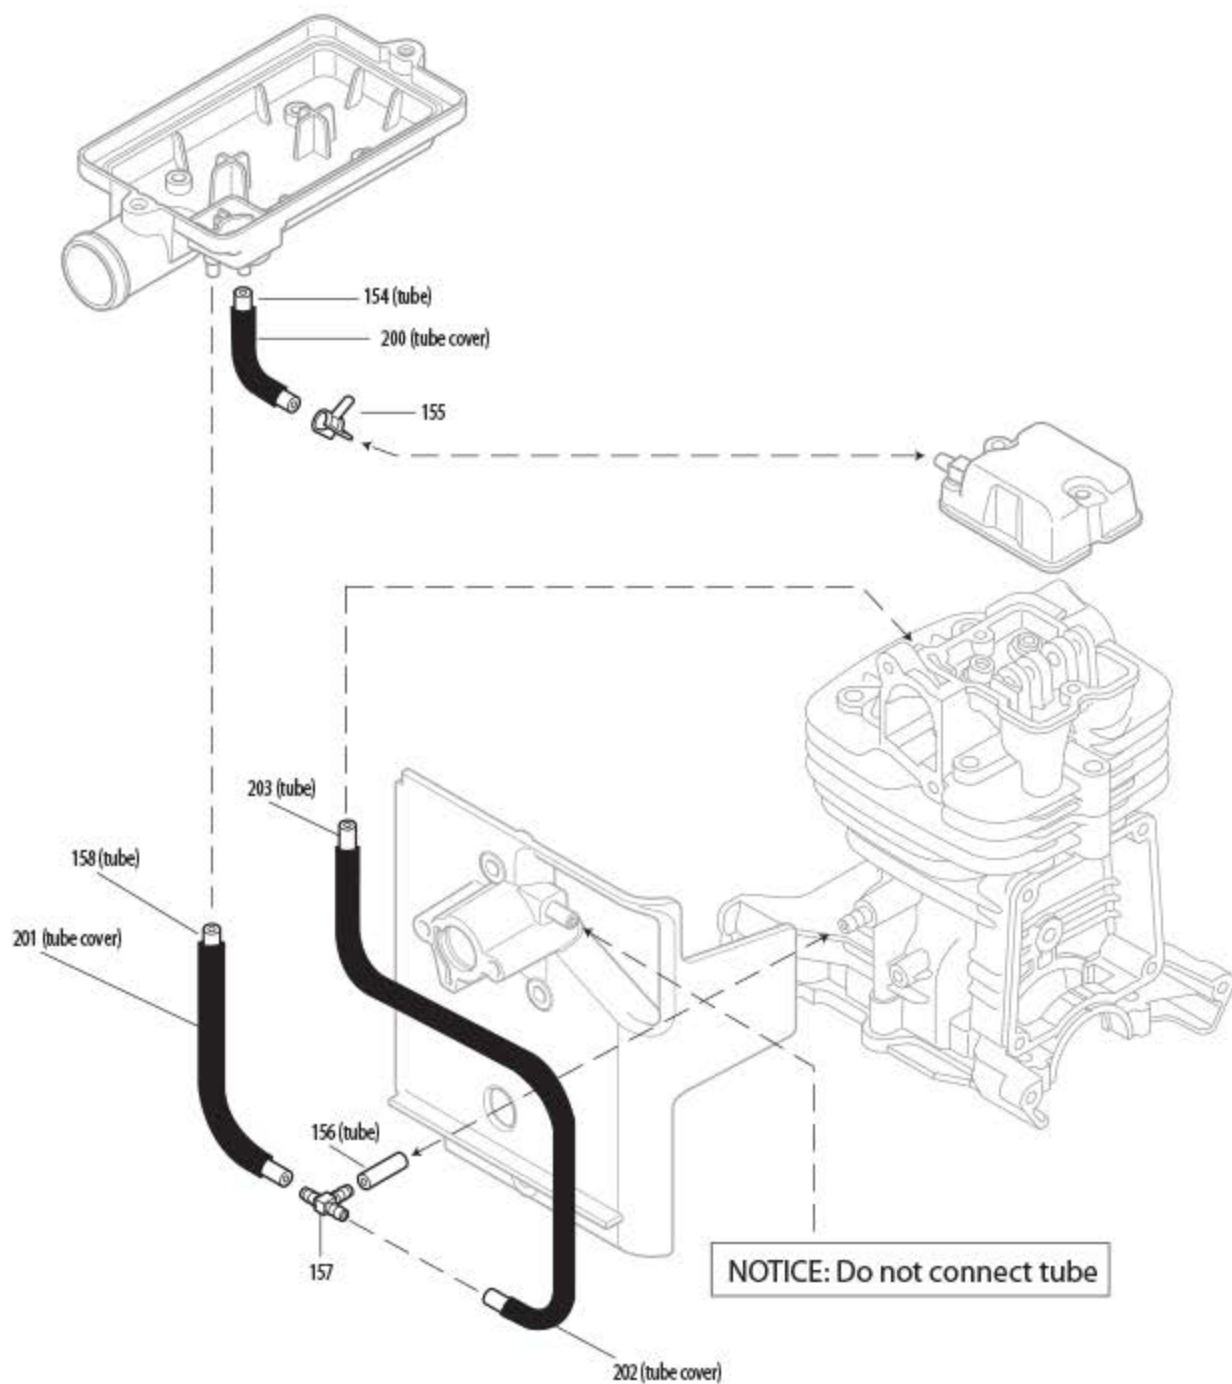
TYPE 2 - OIL TUBE ASSEMBLY

**TYPE 2 (Page 11)**

Oil return passage is added here.

Oil return passage is eliminated.
